SLCo area Collision Analysis and Reconstruction Unit

Collision Reconstruction Report

Unified Police Case # [REDACTED]
 Collision Location: 900 E 3300 S Millcreek, UT
 Collision Date: Friday 06/24/22 0757 hrs

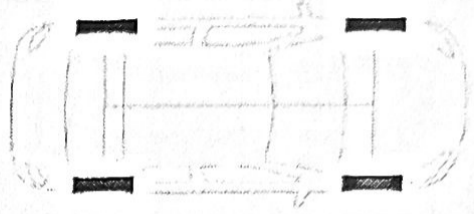
vehicle identification number: [REDACTED]

Make:	Hyundai	tire size:	actual size:
Model:	Accent	185/60R16	
year:	2014	UT listing	U510JH

The involved Hyundai (vehicle #2) showed significant damage from the initial impact and secondary impact with vehicle #1. The damage to passenger rear corner is indicative of the secondary impact as the two vehicles rotate post impact. The damage from the initial impact was along the passenger side from the front bumper to the "A" pillar, extending into the passenger door. Both the right front and rear tires were displaced from the initial and secondary

impacts respectively. In addition to the damage from vehicle #1 there was some damage to the driver side rear of the vehicle from impacts with vehicle #3 and vehicle #4.

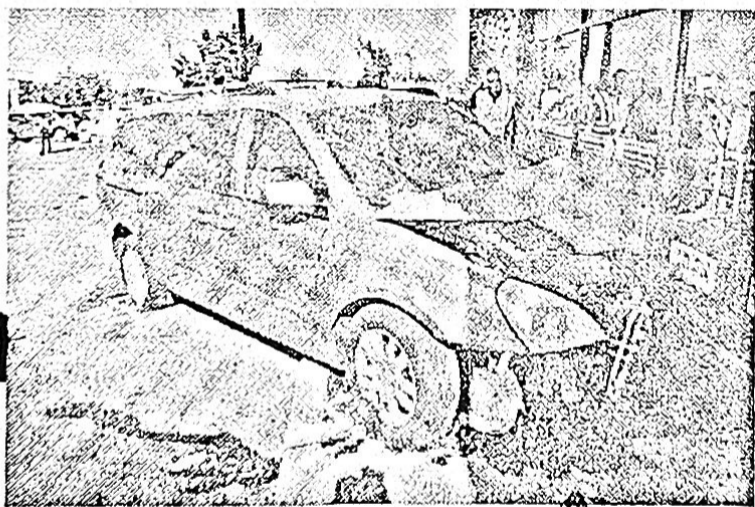
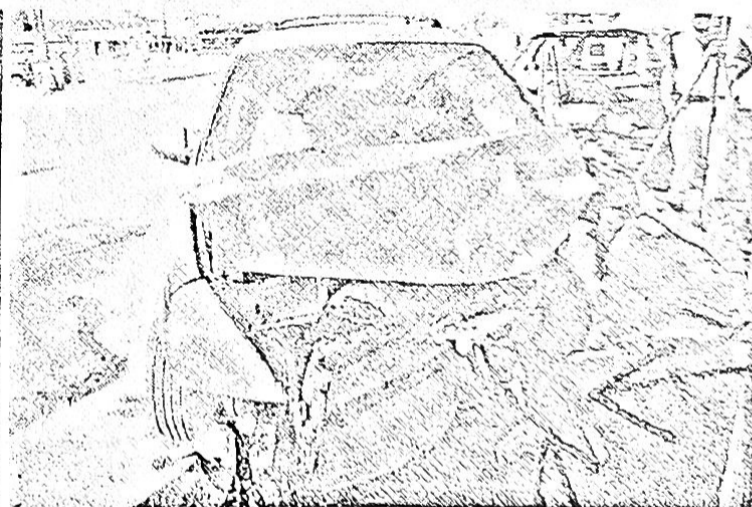
no fluid trail

pooled fluid

damage from 2nd (secondary) collision w/ Honda CRV

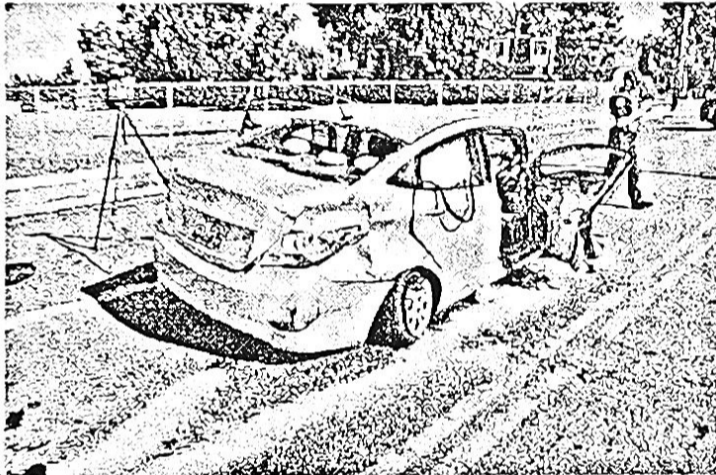
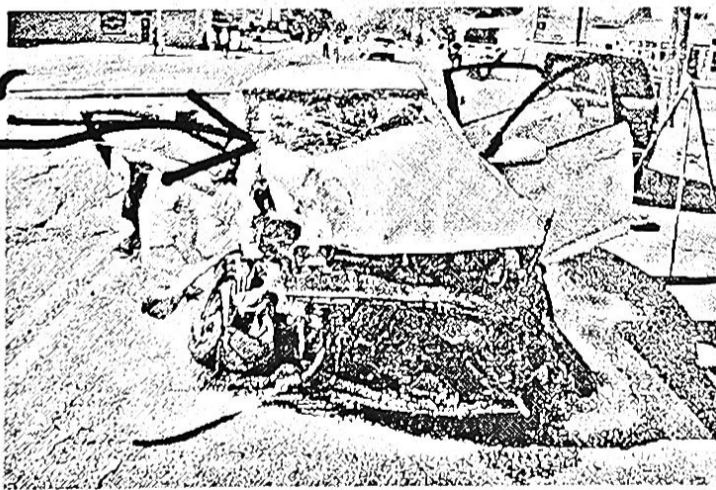
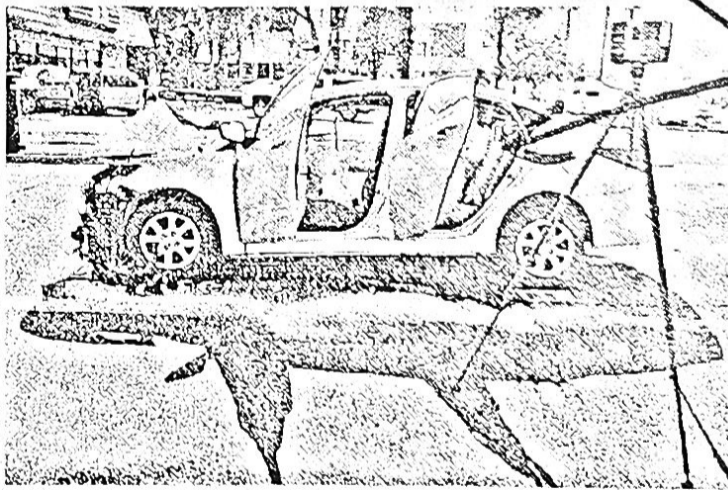
Steel
door
1/3.
Plastic
bumpers
?

NO
mention
of #
2 car
rolled

NO DAMAGE - AND #3 + #4 MOVED
shows on image

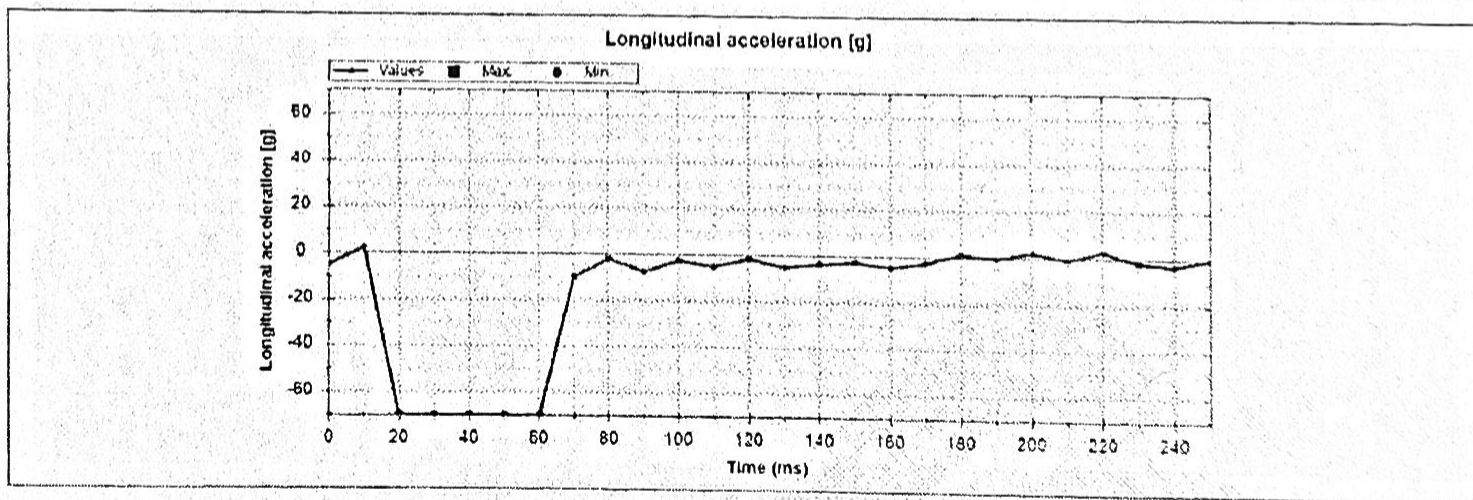
Longitudinal crash pulse_acceleration (g, 0 ~ 250msec)

System status at event show both the driver and passenger were wearing seatbelts at the time of the collision. Deployment event data showed the deployment command occurred at 17 ms.

The EDR recorded both a longitudinal and lateral crash pulse.

→ original documentation needed, charges based on injury to a pregnant woman — needs proof she wore a seatbelt.

38 mph for initial speed — reduction — "continued" moving!

Looking at the charts you can see between 20 and 60 ms the chart maxes out the range and 65 G's along the longitudinal and 70 G's laterally. This means the accelerometers are maxed out and data is underreported.

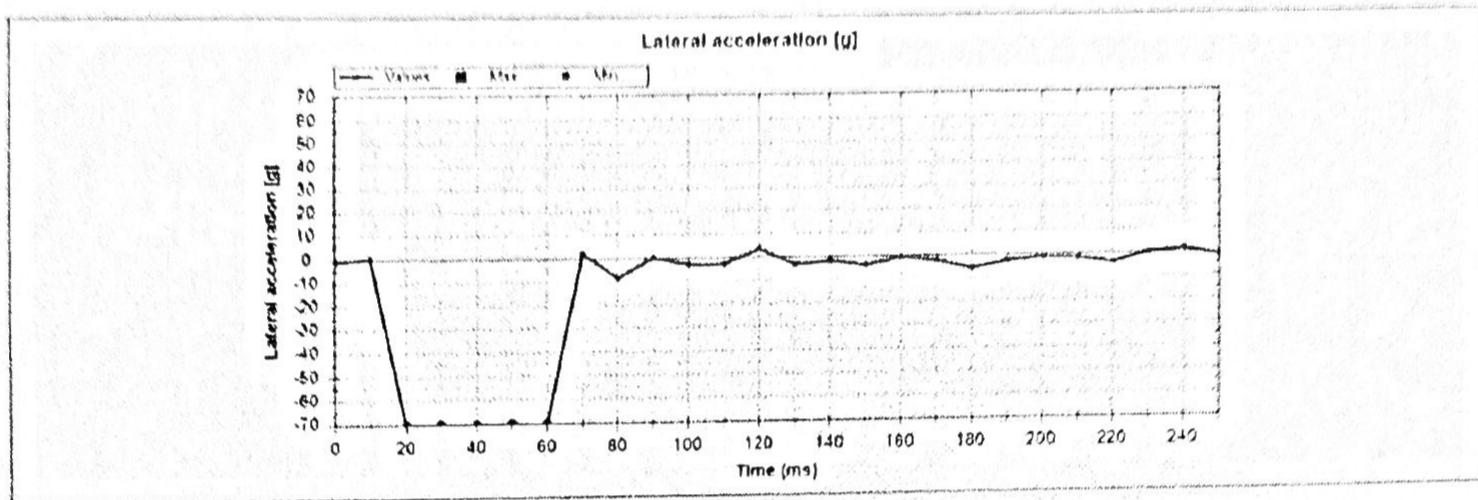
Lateral crash pulse acceleration (g, 0 ~ 250msec)

wrong - 52.5 kph (see pg 24)

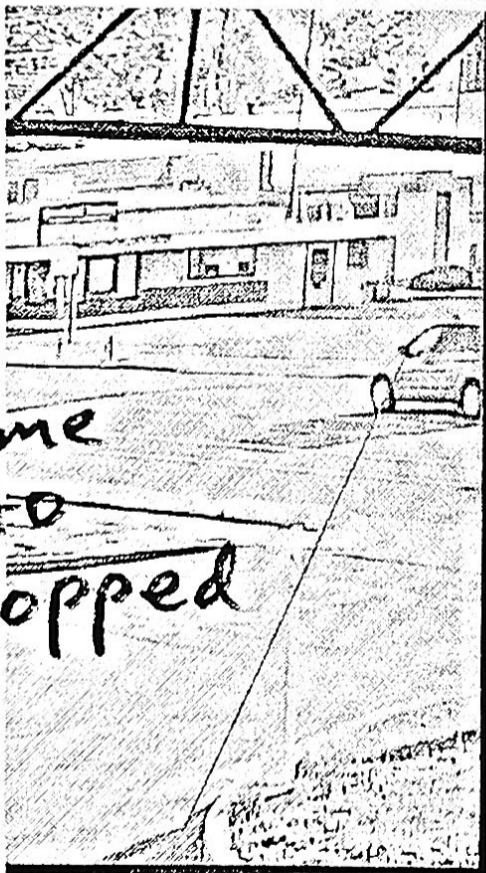
same
photo
-cropped

Although the video can't be used for accurate calculations, I can reference off similar landmarks to gain a rough estimate of how far the vehicle traveled from its first visibility to the area of impact. The distance the vehicle traveled was approximately 289.7 feet.

no two photos of car on road for determining speed. $D/T = R$
